INSPECTION REPORT OF THE
VEGETATIVE CONDITIONS ON THE SAFFORD EROSION PROJECT

October 23 to 26, 1934

by
W. G. McGinnies
and
E. K. Douglass

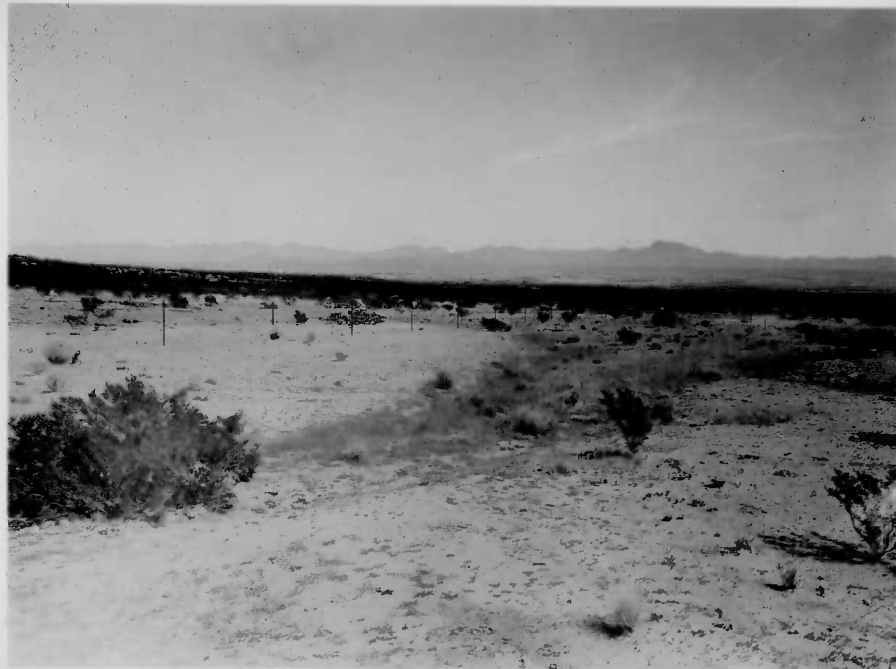
Photograph No.2: Primary Erosion Control -
Black Canyon, Plot No.2

Vegetation often proves to be an efficient and powerful agent in the control of runoff and destructive erosion, as shown in the central portion of this photograph.

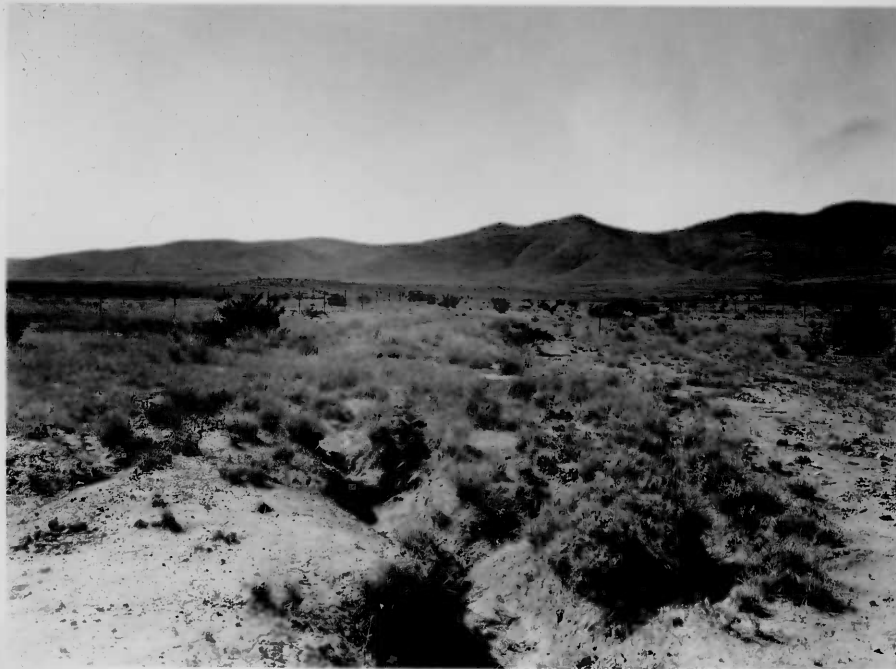
Photograph No.3: Primary Erosion Control -
Black Canyon, Plot No.2

A few dollars spent for dams and control of
grazing will save many areas such as this.

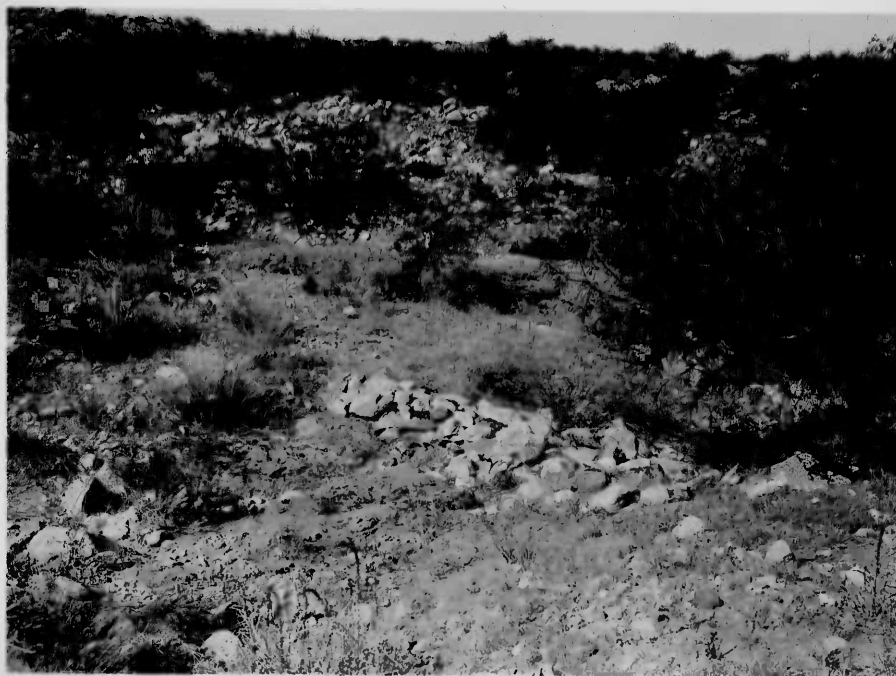
Photograph No.4: Primary Erosion Control -
Hawk Hollow.

Hardly more than a pile of rocks in a depression, but it is holding back its share of water and silt and creating a favorable habitat for the growth of vegetation.

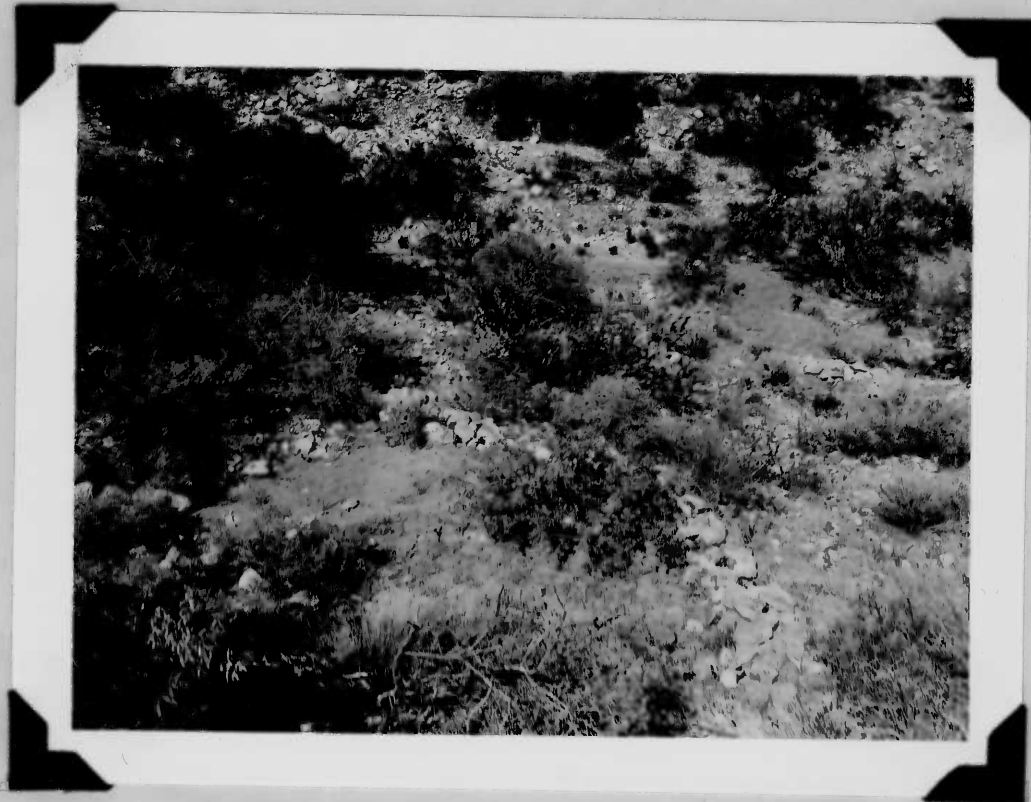
Photograph No.5: Primary Erosion Control -
Hawk Hollow:

This unpretentious dam is successful in checking erosion, and revegetation has started after one season.

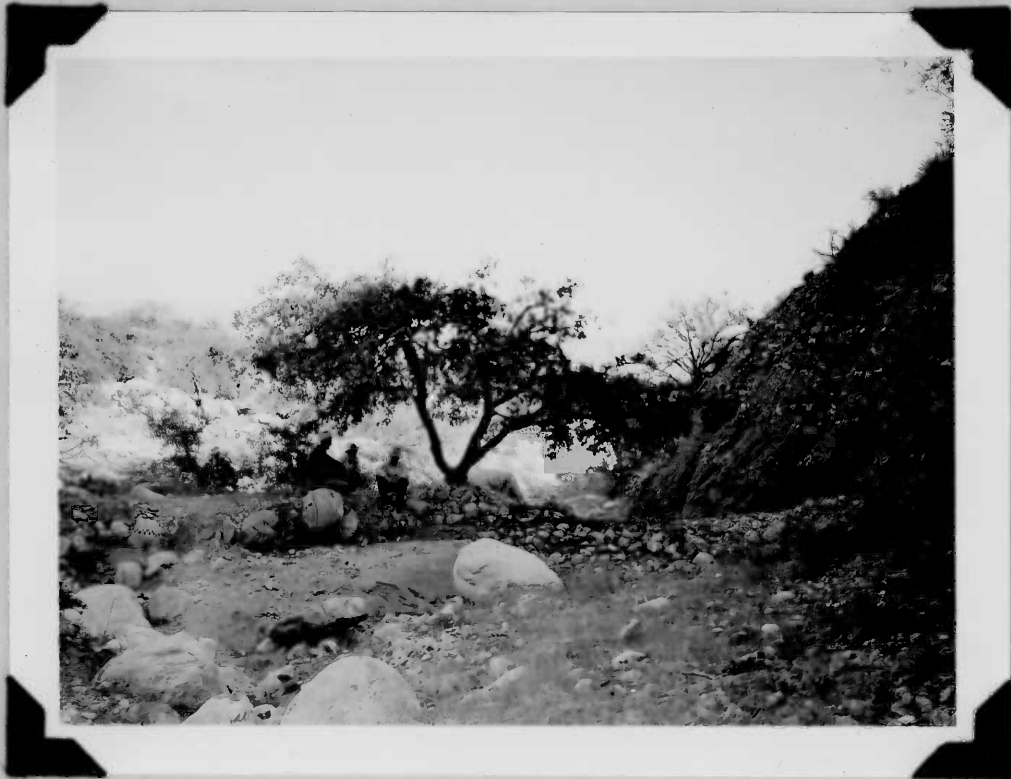
Photograph No. 6: Secondary Erosion Control on
a Short Drainage - Hawk Hollow.

This dam has been effective in the control of
erosion. It offers limited possibilities for
revegetation.

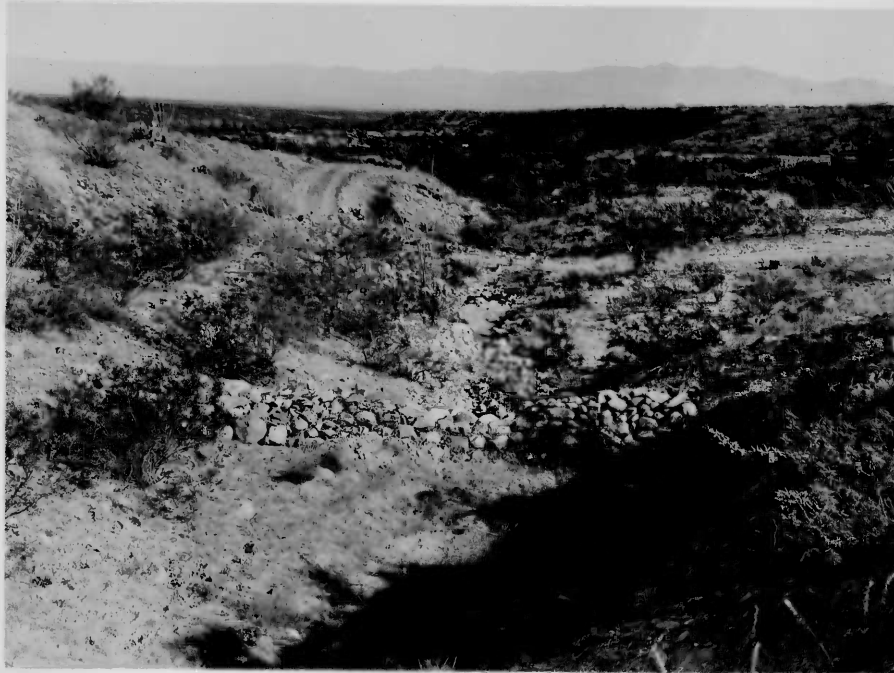
Photograph No.7: Secondary Erosion Control -
Hawk Hollow;

A series of such dams might sink a considerable
volume of water to replenish the ground water
supplies.

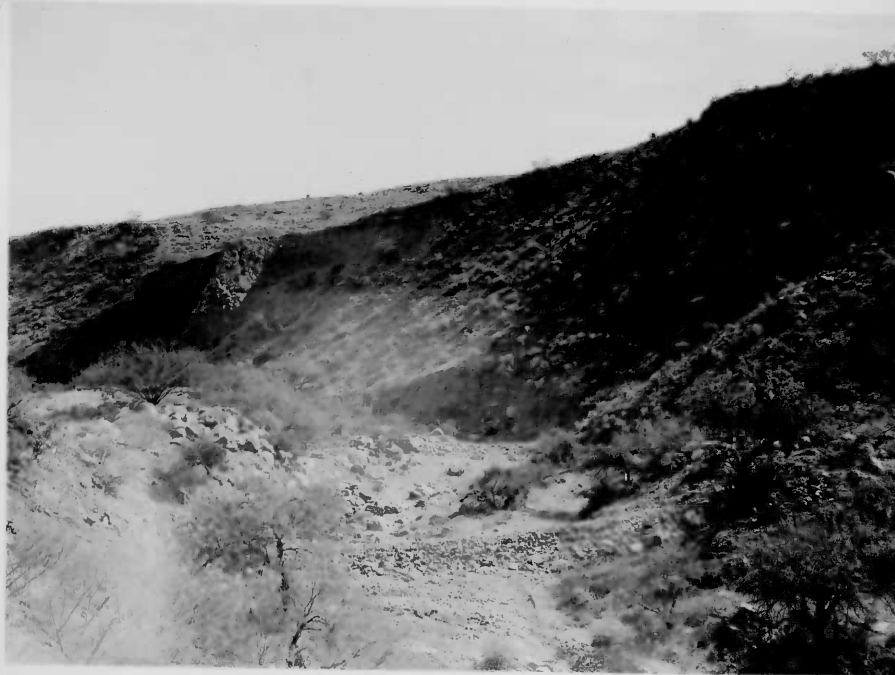
Photograph No. 8: Tertiary Erosion Control -
Hawk Hollow.

The forces to which dams such as this are exposed may be terrific. There is little opportunity for revegetation here.

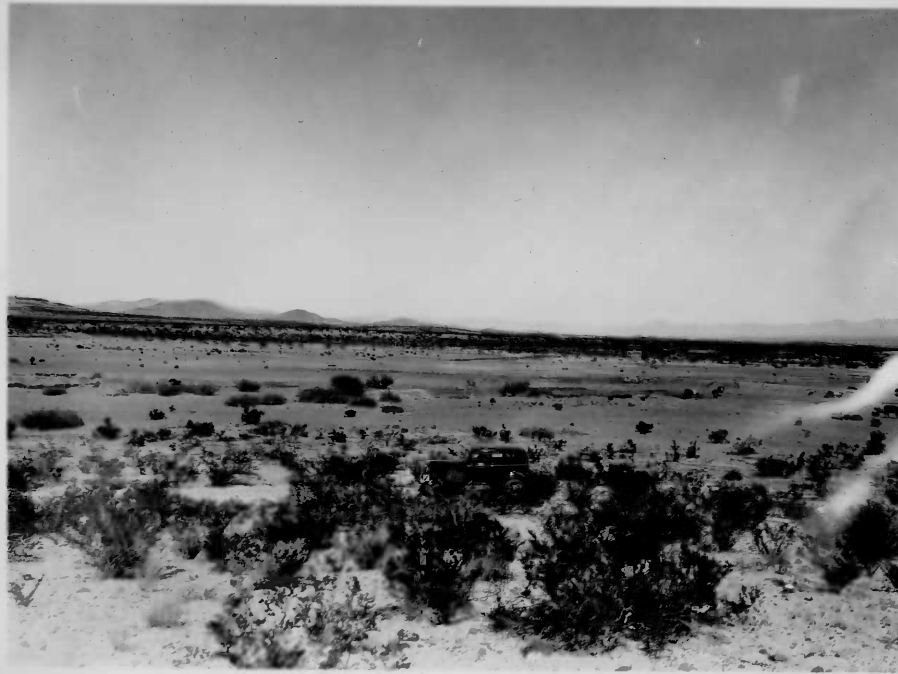
Photograph No. 9: Tertiary Control on an Alluvial Flat - Black Canyon, Plot No. 2

Photograph No. 9, taken near the protected plot on Black Canyon shows the concentration of live stock along the dam because of the water remaining at the close of the rainy season. This is one feature which will probably have to be corrected. At present the dams have resulted in increasing the intensity of grazing whereas if optimum results are to be expected, the degree of grazing should be decreased in the vicinity of dams, especially those located on the deep alluvial flats. In such locations as this, it is expected that artificial re-seeding and planting will prove to be most effective and of greatest economic value. However, it is almost certain that such operations will fail unless grazing by domestic stock and rodents is controlled.

The heavy grazing here is going a long way toward nullifying the beneficial effects of man's efforts for regeneration.

As the dikes in this area are still holding water, thus tending to bring about a congregation of stock around them, an already badly overgrazed condition is being aggravated. For this reason, it is strongly recommended that the engineering works in this area be fenced, at least in part.
